Report No.  
SSRP – 2000/13

**FLEXURAL BEHAVIOR OF  
CIRCULAR HOLLOW COLUMNS  
WITH A SINGLE LAYER OF  
REINFORCEMENT UNDER SEISMIC  
LOADING**

Final Research Report for Caltrans under Contract No. 59A0051

Department of Structural Engineering  
University of California, San Diego  
La Jolla, California 92093-0085

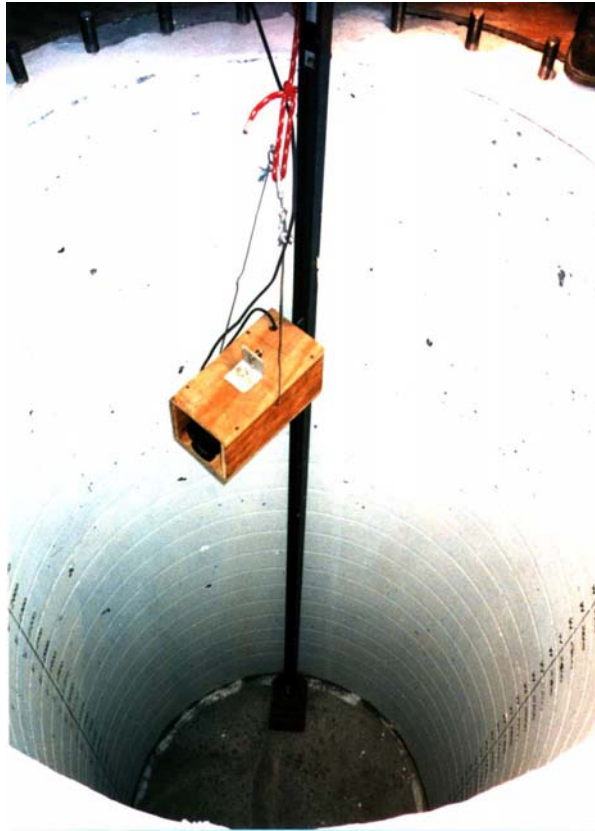
Fig. 2.9 Movable Video Camera Placed Inside

A movable video camera was placed in the void section to observe damage developed on inside face concrete during testing. The video camera was supported by a guide rail set up near the south inside face as shown in Fig. 2.6 and 2.9. The system provided a panoramic view of the inside except the south face.

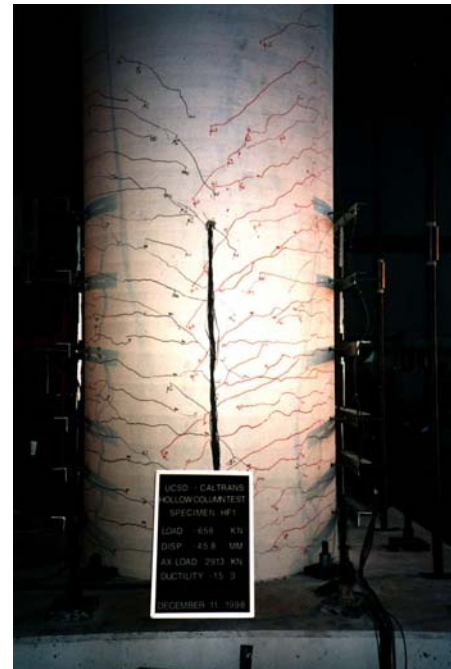
Fig. 3.3 Crack Pattern at Ductility 1.5

New flexural cracks formed over the whole height of the concrete section. Fig. 3.3 shows the flexural cracks developed on the north face and shear cracks developed on east face at the ductility 1.5. The crack widths of the major flexural and shear cracks were 0.35mm and 0.2mm, respectively. It was noted that new vertical splitting cracks developed on north inside face over a height of 800mm from the base as shown in Fig. 3.4.

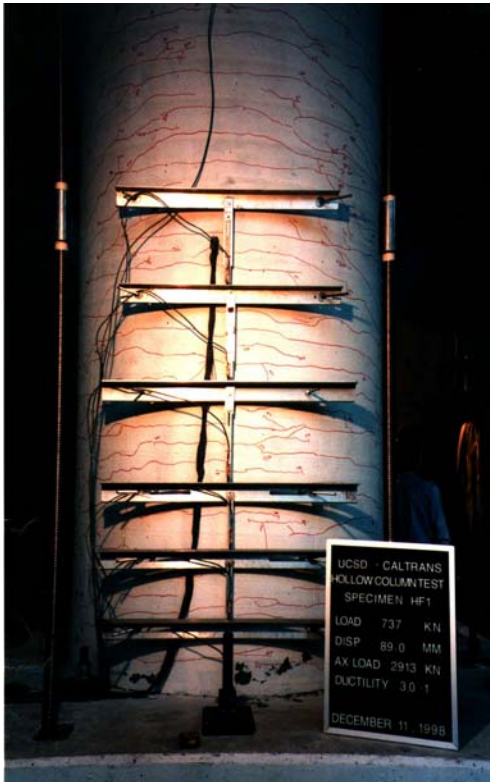
Fig. 3.6 Crushing of Cover Concrete at Ductility 3.0

Incipient crushing of the cover concrete was found at the column base as shown in Fig. 3.6. At this level, some flexural and shear cracks widened to nearly 2mm and 0.7mm, respectively. Fig. 3.7 shows the horizontal cracks and diagonal cracks appeared on the north and east inside face, respectively. It is noted that no concrete crushing was observed on inside face at the ductility 3.0.

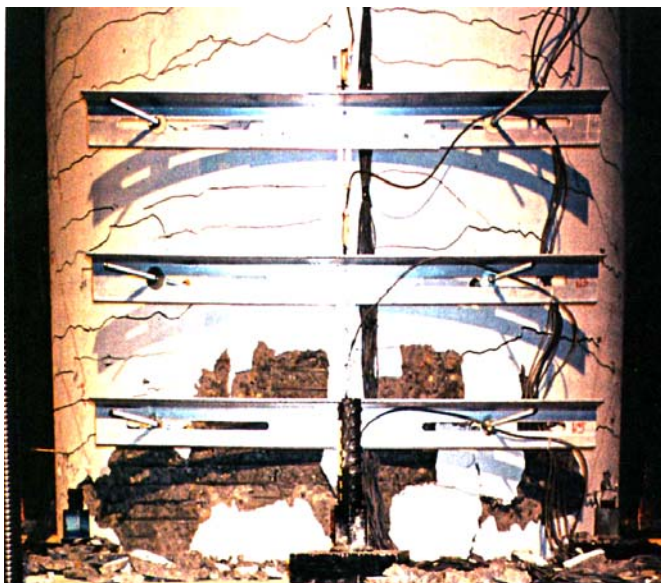
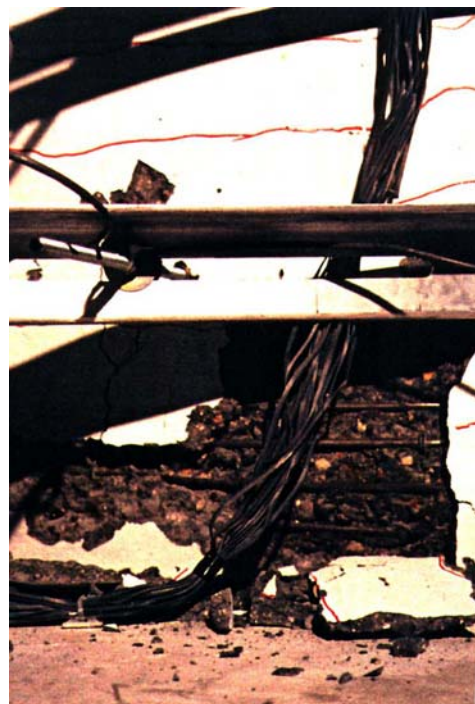
Fig. 3.8 Failure of Column Base at Ductility 4.0

In the first push cycle to ductility 4.0, no longitudinal reinforcement buckled as shown in Fig. 3.8, while the inside face concrete was crushed over a height of 600mm from the base as visible in Fig. 3.9. Subsequently, the lateral force significantly dropped at the displacement of 104mm, corresponding to the ductility 3.5. On the first return cycle, the lateral force degraded at the displacement of 96mm (ductility = 3.3) due to failure of the inside face concrete.

Figs. 3.18 to 3.24 show the strain hysteresis responses of the spiral at the north face. The spiral strain at a level of 280mm height (where is nearly mid-height of the theoretical plastic hinge length) has reached about 1380 microstrains at the maximum useful ductility 3.5 and the spiral has yielded immediately after crushing of the inside face concrete. Similar strain behavior was also observed on the spiral at levels of 140mm, 420mm and 560mm height where the inside face concrete spalled off as proved in Fig. 3.10. Therefore, it can be said that the maximum effective lateral pressure that occurs when the spirals are stressed to their yield strength was not induced to the concrete shell in the plastic hinge region before failure, and that yield strain was only induced by the buckling of the longitudinal bars, other than by concrete confinement. At the sections of 700mm and 840mm height, the strain responses showed almost elastic behavior and indicated peak strains (approximately 1000 microstrains) in a moment of crushing of the inside face concrete. A dramatic increase in strain after concrete failure was not noted at these sections since the longitudinal bars buckled up to 550mm height from the column base as shown in Fig. 3.8.

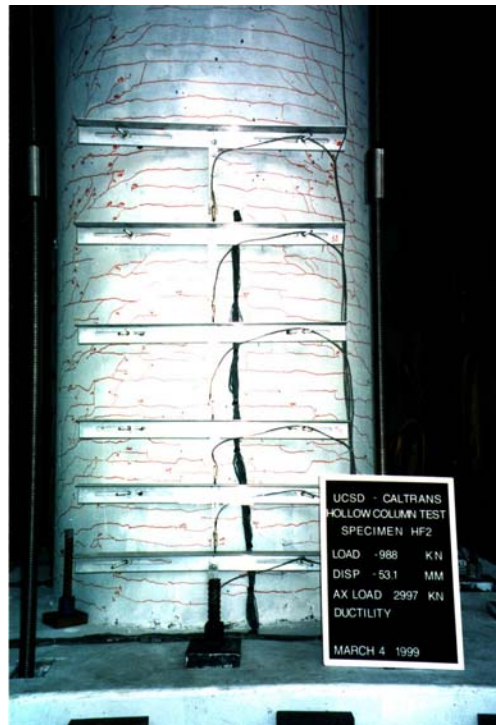
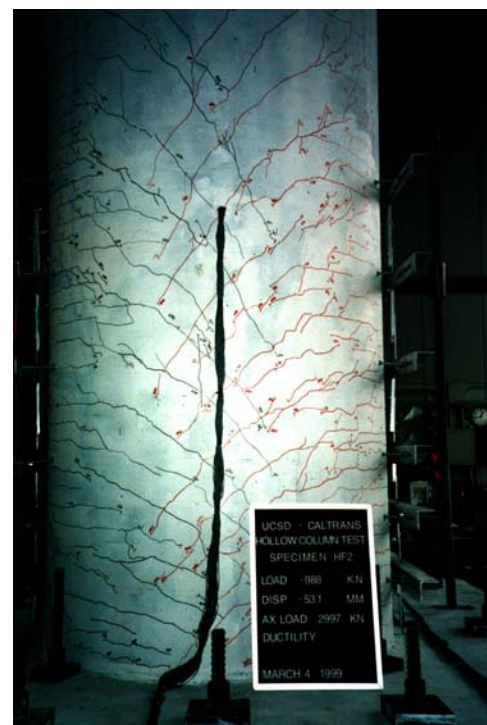
Fig. 4.2 Crack Pattern at Ductility 1.0

Fig. 4.2 shows the horizontal cracks on the north face and shear cracks developed on the east face at the ductility of 1.0. Some vertical splitting cracks were seen at this level. The maximum horizontal crack width was 0.35mm and the biggest shear crack also widened to 0.35mm.

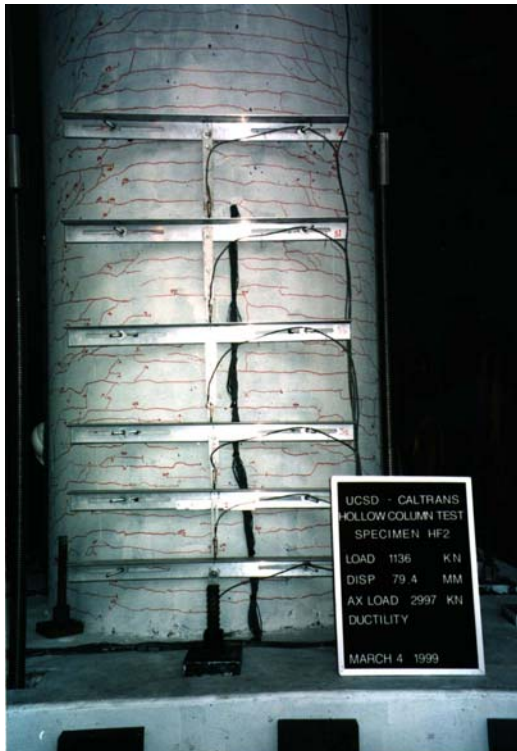
(b) Diagonal Cracks (East Face)

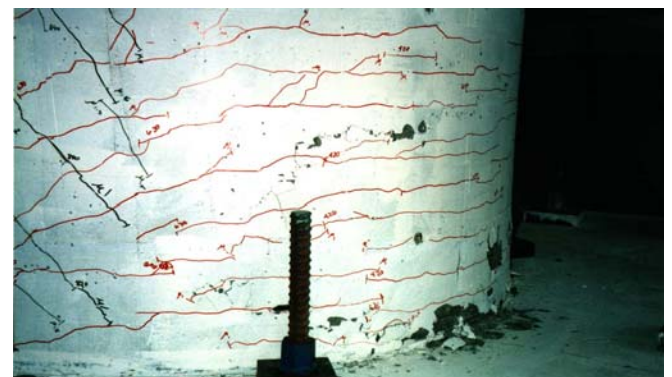
Fig. 4.4 Failure of Column Base at Ductility 2.0

(b) Close-up

In the first push cycle to ductility 2.0, the inside face concrete on the north face was crushed over a height of 500mm from the base as shown in Fig. 4.4 and the lateral force significantly dropped at the displacement of 94.7mm, corresponding to the ductility 1.8. On the other hand, although the onset of minor crushing was recognized on the outside face concrete, no longitudinal reinforcement buckled and no core concrete spalled off to outside at this level. The test observations obviously show that the column failure occurred due to the crushing of the inside face concrete.
